**Docket No. 217 – Development and Management Plan Inspection**

Northeast Utilities Service Company Certificate of Environmental Compatibility and Public Need for the construction of a 345-kV electric transmission line and reconstruction of an existing 115-kV electric transmission line between Connecticut Light and Power Company's Plumtree Substation in Bethel, through the towns of Redding, Weston, and Wilton, and to the Norwalk Substation in Norwalk, Connecticut.

**Date:** November 4, 2004

**Location:** Norwalk Substation Expansion

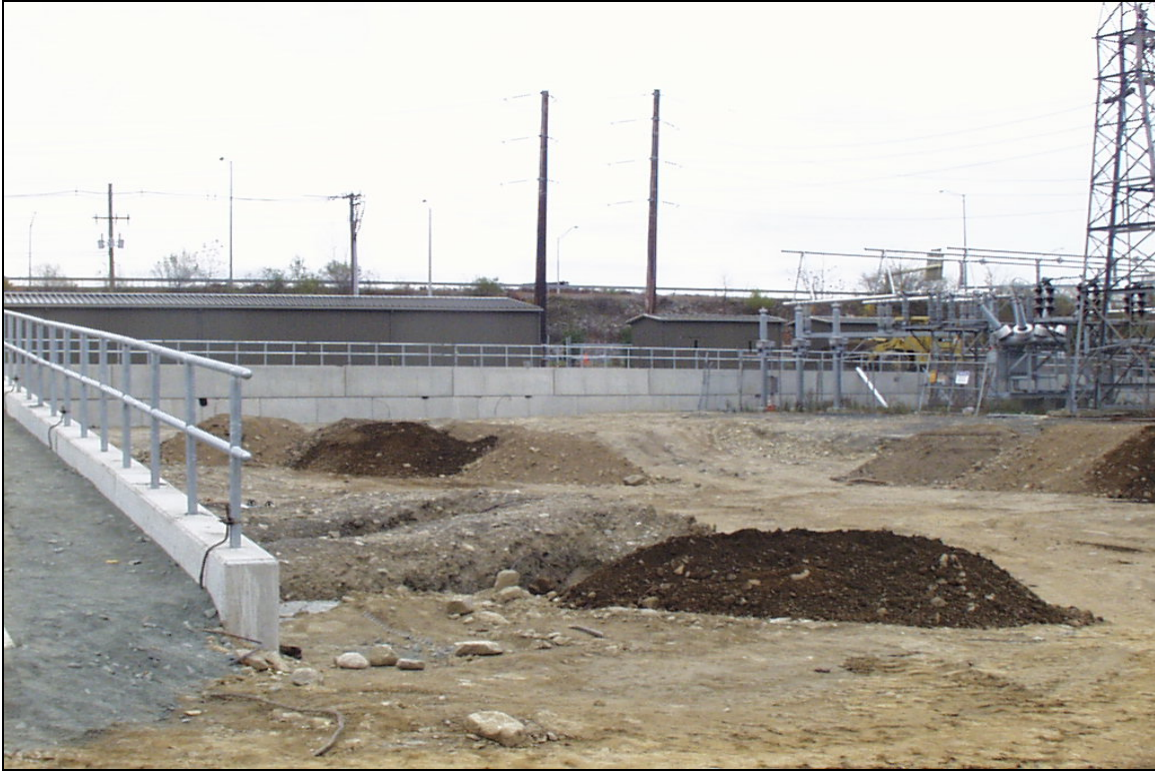
View of retaining wall 3. Although small stockpiles remain, the area is contained. 11/04/04

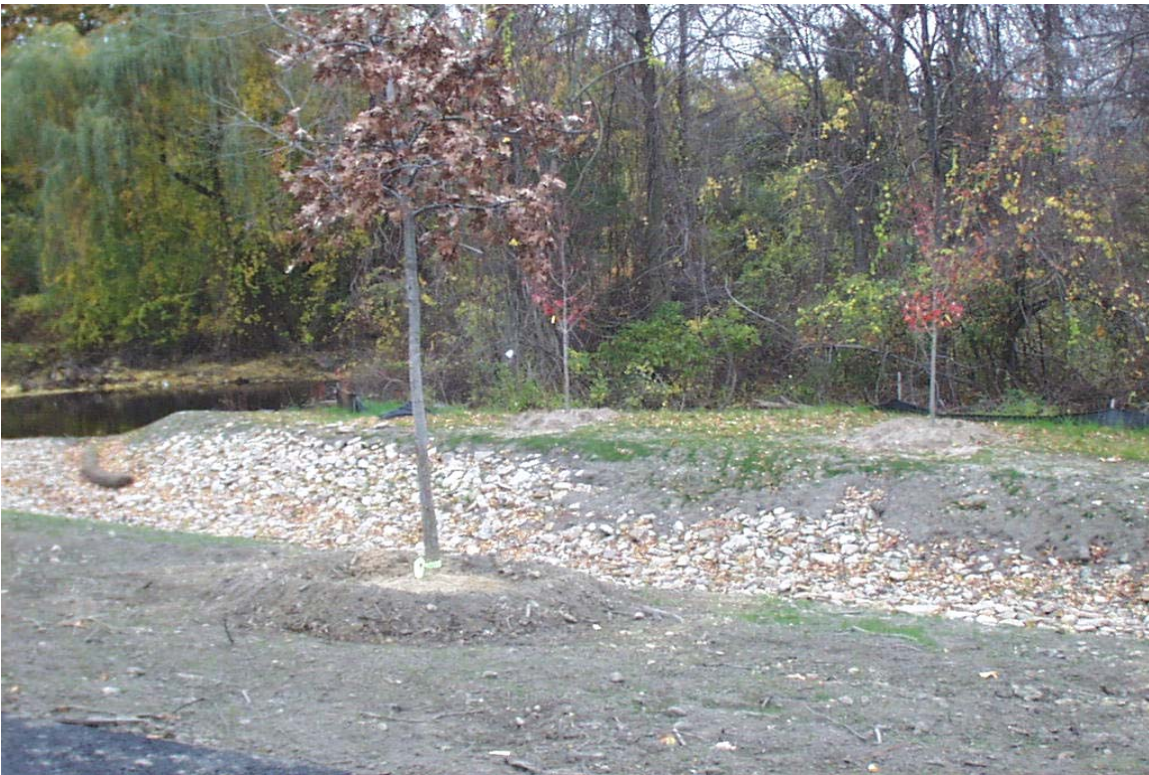
View of the overflow channel with the recent plantings. Some minor erosive gullies were noted in a few locations along the top of the channel. The area will be hydroseeded in an attempt to stabilize for winter. 11/04/04

Areas of Inspection	Observation	Recommended Action
Erosion and Sediment Controls continued	- One spot of fence near wall #5 could use reinforcement or repair as it is under strain from sedimentation 9/23-11/04/04	- Fence should be reinforced in this location before winter if practicable. It does not pose much of a problem if the area is hydroseeded as proposed. 11/04/04
	-The areas around the recent landscaping and the overflow channel will be hydroseeded in the near future in an attempt to stabilize the area. This includes all the soil along the top and sides of the channel. 11/04/04 - Some small erosive gullies were noted in the soil along the channel. 11/04/04	- Best efforts should be made to get as much vegetative cover as possible at this time of year. The hydroseeding should be a good solution as a tackifier and mulch is included in the mix. 11/04/04

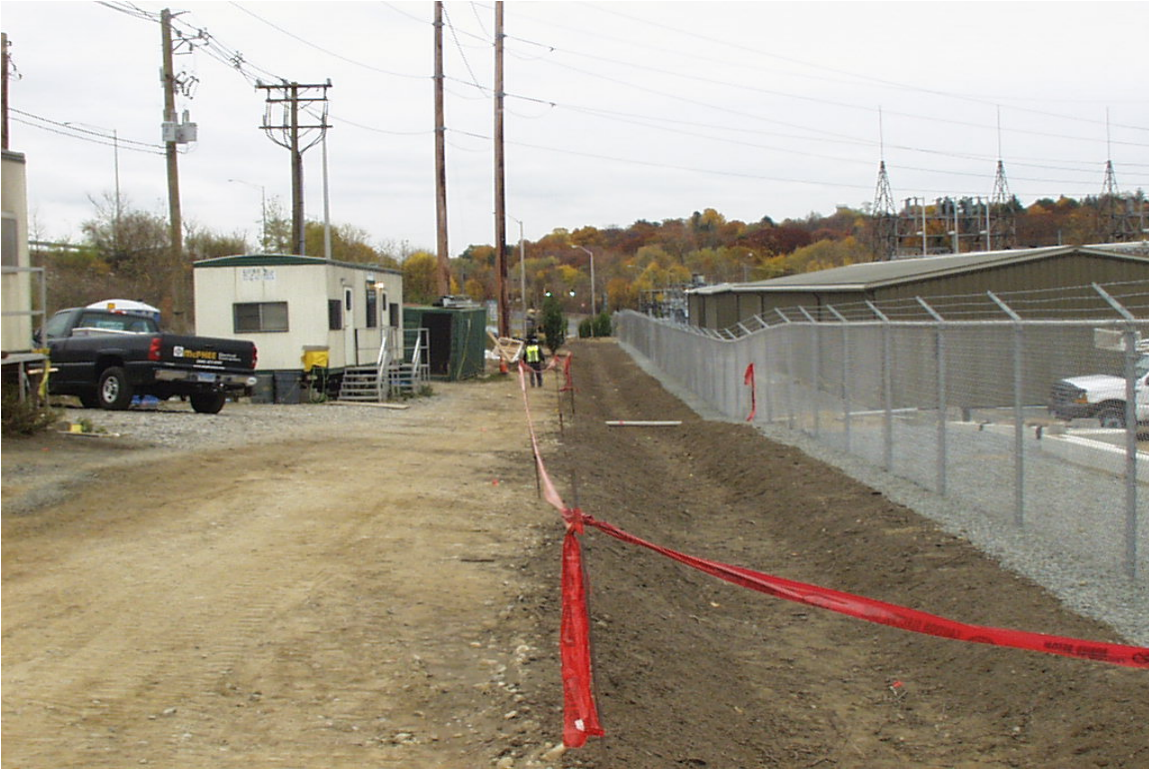
View of the area up near the Route 7 ramp where landscaping is occurring near the perimeter fence to the yard. 11/04/04

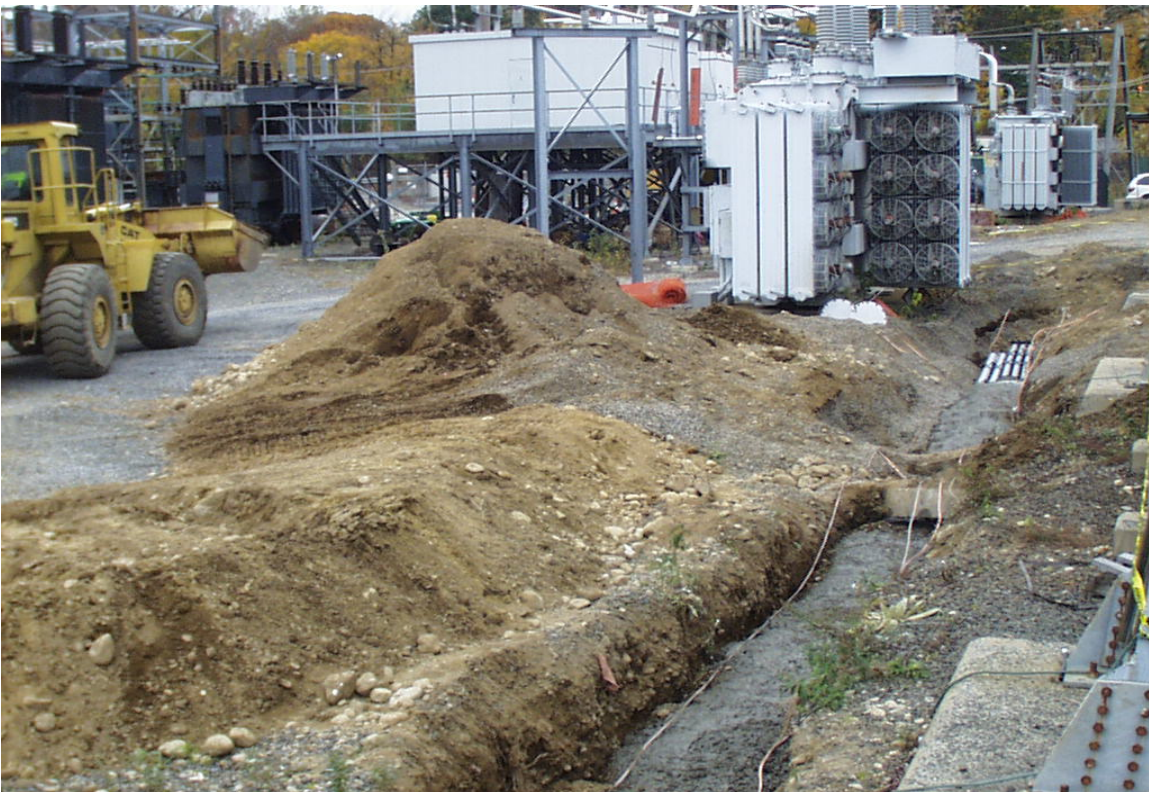
A small excavation for a service conduit is taking place within the internal charged yard. All areas are contained. 11/04/04

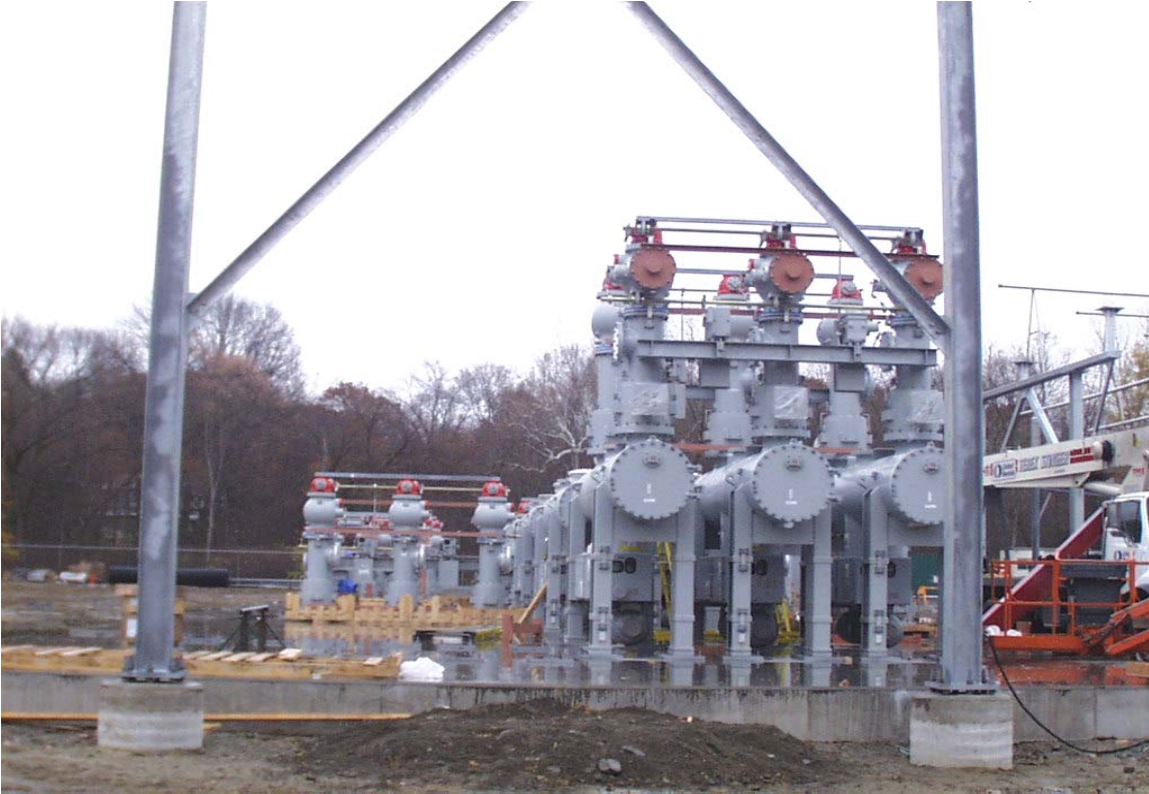
Plumtree Substation: All major work at Plumtree now consists of setting up equipment on the concrete slab. 11/04/04

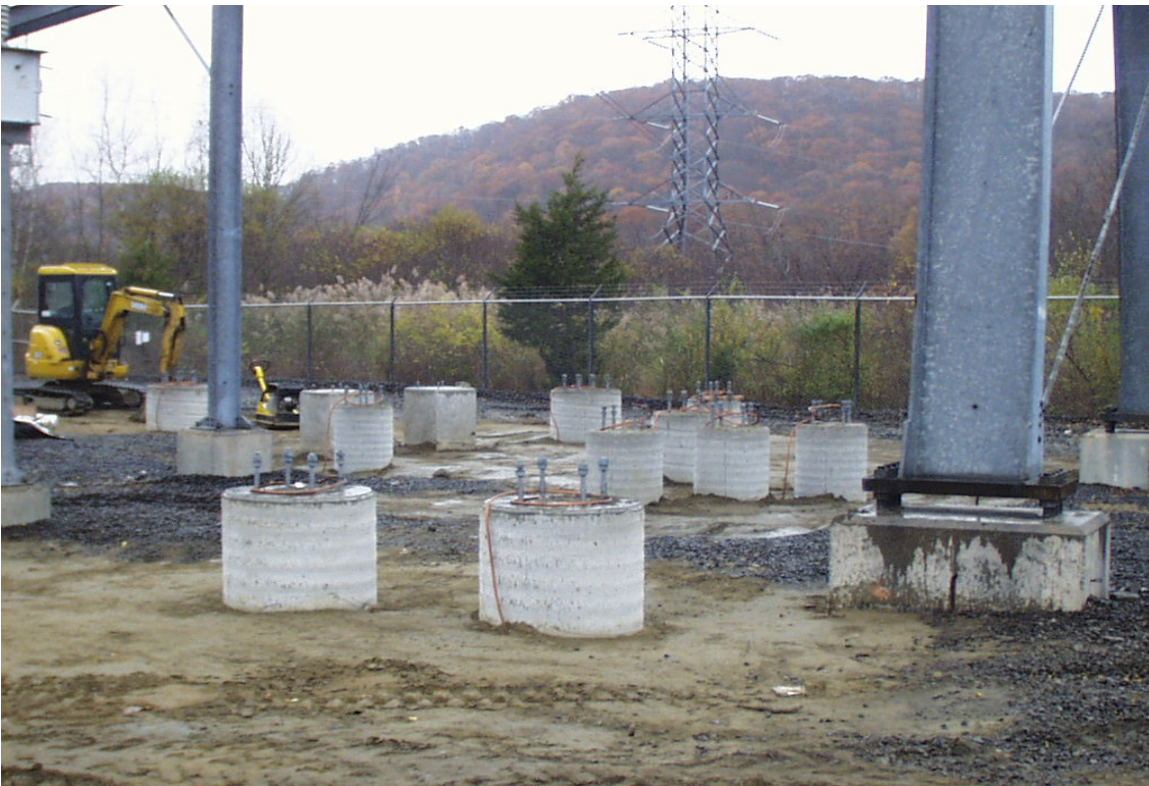
All other excavations for footings and structures in the yard are basically completed and backfilled. 11/04/04
